**Flood Control Project Maintenance
Levee Inspections**
LMA District Cover Sheet
Spring 2018 Levee Inspection Results

Reclamation District No. 2060 Hastings

Spring 2018 Levee Inspection Results

Waterway			Bank	Unit Miles
Unit No. 01 Lindsey Slough			Left	6.97
	Spring (March - May)	Summer (June - August)	(September - November) Fall	Winter (December - February)
Unit Maintenance Rating (Fall Only)				
Date of Inspection	3/28/2018 - 3/28/2018			
DWR Inspector	Keith Millard			
Accompanied By	Mark Boyd RD 2060 Hastings Tract			
	Michael Moncrief MBK Engineers			
	Jack Kuechler RD 2060

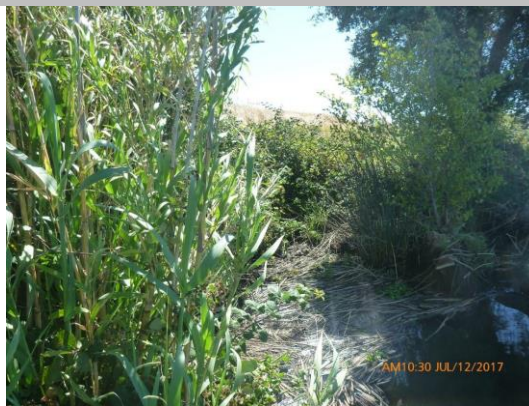
Photo 1 of 6 : SP_2018_RD2060_241_5_20180305_00001.jpg

LM Start	0.40	Rating **	M	Issue No.	5
LM End	0.40	Issue Type +	Ma	Location *	
Category	Supplemental			GPS Latitude/Longitude	
				Start	End
Item	2017 Storm Damage			38.247894 °	38.247911 °
				-121.703492 °	-121.703539 °
DWR ID	DWR_RD2060_01_f _ 2017_5				
Comment Code					
Inspector Comment					
Levee Evaluation Comments					
Description:Erosion commences approximately 3/4 of the way down the slope, near the water line towards the waterside toe.					
Site ID No:358					
Site Designation:LMA-185					
Repair Type: Erosion					
Rating:Area of Concern					
Field Date:7/12/2017					
Notes: Small erosion into bank.

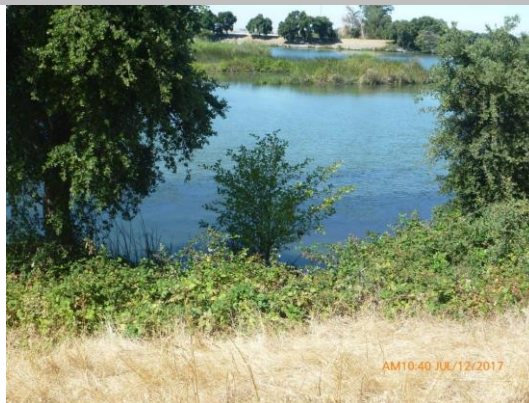
Photo 4 of 6 : SP_2018_RD2060_241_5_20180305_00004.jpg

LM Start	0.40	Rating **	M	Issue No.	5 (cont)	
LM End	0.40	Issue Type +	Ma	Location *		
Category	Supplemental			GPS Latitude/Longitude		
				Start		End
Item	2017 Storm Damage			38.247894 °		38.247911 °
				-121.703492 °		-121.703539 °
DWR ID	DWR_RD2060_01_f _ 2017_5					
Comment Code						
Inspector Comment						
Levee Evaluation Comments						
Description:Erosion commences approximately 3/4 of the way down the slope, near the water line towards the waterside toe.						
Site ID No:358						
Site Designation:LMA-185						
Repair Type: Erosion						
Rating:Area of Concern						
Field Date:7/12/2017						
Notes: Small erosion into bank.

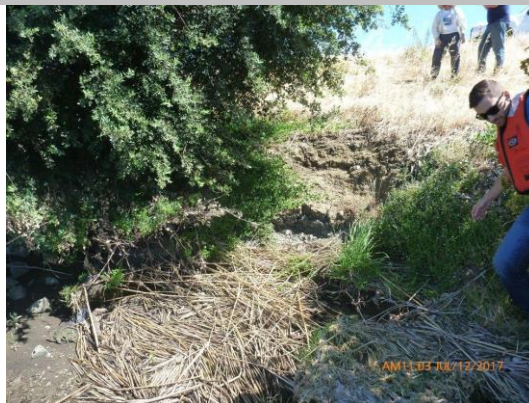
Photo 2 of 3 : SP_2018_RD2060_241_8_20180305_00008.jpg

LM Start	0.41	Rating **	M	Issue No.	8 (cont)	
LM End	0.42	Issue Type +	Ma	Location *		
Category	Supplemental			GPS Latitude/Longitude		
				Start	End	
Item	2017 Storm Damage			38.248036°	38.248017°	
				-121.703539°	-121.703789°	
DWR ID	DWR_RD2060_01_f_2017_8					
Comment Code						
Inspector Comment						
Levee Evaluation Comments						
Description:Erosion commences approximately halfway down the water side slope extending in to existing rip rap. Existing rip rap appears to have been pulled off in this section.						
Site ID No:359						
Site Designation:LMA-186						
Repair Type: Erosion						
Rating:Area of Concern						
Field Date:7/12/2017						
Notes: Site had riprap but is eroded away. Minor erosion in toe of levee.

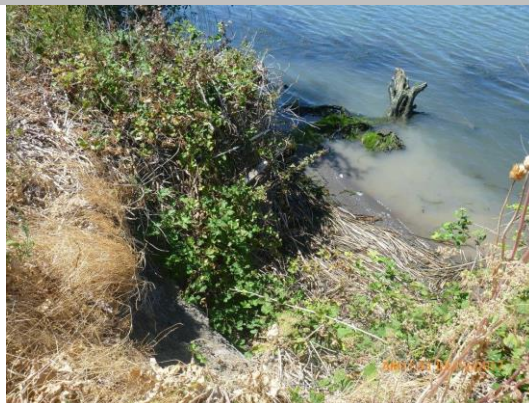
Photo 1 of 3 : SP_2018_RD2060_241_9_20180305_00010.jpg

LM Start	0.75	Rating **	M	Issue No.	9	
LM End	0.76	Issue Type +	Ma	Location *		
Category	Supplemental			GPS Latitude/Longitude		
				Start	End	
Item	2017 Storm Damage			38.249314 °	38.249400 °	
				-121.709461 °	-121.709608 °	
DWR ID	DWR_RD2060_01_f_2017_9					
Comment Code						
Inspector Comment						
Levee Evaluation Comments						
Description:Erosion commences approximately halfway down the water side slope extending in to existing rip rap. Erosion is concentrated near the waterline. Existing rip rap appears to have been pulled off in this section.						
Site ID No:360						
Site Designation:LMA-187						
Repair Type: Erosion						
Rating:Area of Concern						
Field Date:7/12/2017						
Notes: Erosion looks old but has progressed this year.

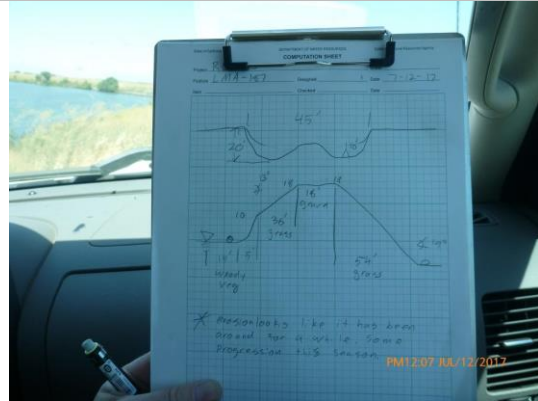
Photo 3 of 3 : SP_2018_RD2060_241_9_20180305_00012.jpg

LM Start	0.75	Rating **	M	Issue No.	9 (cont)							
LM End	0.76	Issue Type +	Ma	Location *								
Category	Supplemental		GPS Latitude/Longitude									
			Start	End								
Item	2017 Storm Damage		38.249314 °	38.249400 °								
			-121.709461 °	-121.709608 °								
DWR ID	DWR_RD2060_01_f_2017_9											
Comment Code												
Inspector Comment												
<p>Levee Evaluation Comments</p> <p>Description: Erosion commences approximately halfway down the water side slope extending in to existing rip rap. Erosion is concentrated near the waterline. Existing rip rap appears to have been pulled off in this section.</p> <p>Site ID No: 360</p> <p>Site Designation: LMA-187</p> <p>Repair Type: Erosion</p> <p>Rating: Area of Concern</p> <p>Field Date: 7/12/2017</p> <p>Notes: Erosion looks old but has progressed this year.</p>

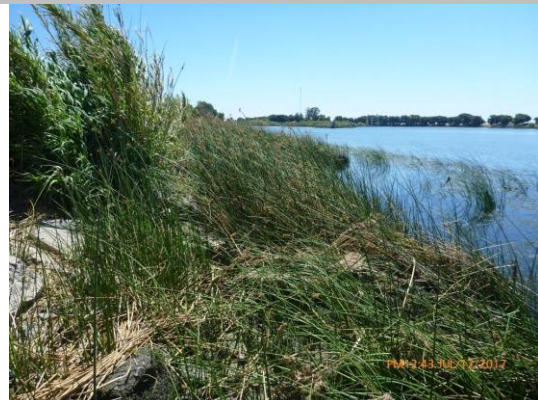
Photo 1 of 4 : SP_2018_RD2060_241_10_20180305_00013.jpg

LM Start	0.92	Rating **	M	Issue No.	10							
LM End	0.93	Issue Type +	Ma	Location *								
Category	Supplemental		GPS Latitude/Longitude									
			Start	End								
Item	2017 Storm Damage		38.250875 °	38.250953 °								
			-121.711942 °	-121.712078 °								
DWR ID	DWR_RD2060_01_f_2017_10											
Comment Code												
Inspector Comment												
<p>Levee Evaluation Comments</p> <p>Description: Sloughing commences approximately halfway down the water side slope.</p> <p>Site ID No: 361</p> <p>Site Designation: LMA-188</p> <p>Repair Type: Erosion</p> <p>Rating: Area of Concern</p> <p>Field Date: 7/12/2017</p> <p>Notes: Minor sloughing, mostly riprap has moved down the slope and into channel.</p>

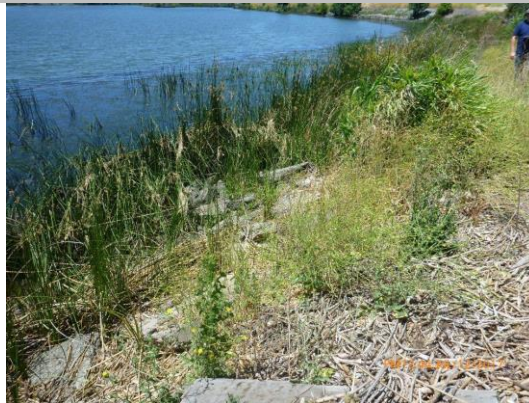
Photo 2 of 4 : SP_2018_RD2060_241_10_20180305_00014.jpg

LM Start	0.92	Rating **	M	Issue No.	10 (cont)
LM End	0.93	Issue Type +	Ma	Location *	
Category	Supplemental			GPS Latitude/Longitude	
				Start	End
Item	2017 Storm Damage			38.250875 °	38.250953 °
				-121.711942 °	-121.712078 °
DWR ID	DWR_RD2060_01_f_2017_10				
Comment Code					
Inspector Comment					
Levee Evaluation Comments					
Description:Sloughing commences approximately halfway down the water side slope.					
Site ID No:361					
Site Designation:LMA-188					
Repair Type: Erosion					
Rating:Area of Concern					
Field Date:7/12/2017					
Notes: Minor sloughing, mostly riprap has moved down the slope and into channel.

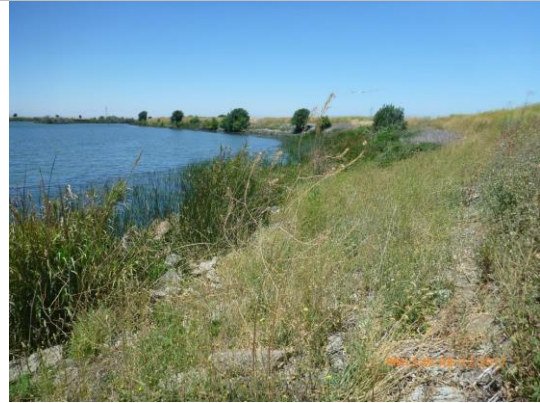
Photo 4 of 4 : SP_2018_RD2060_241_10_20180305_00016.jpg

LM Start	0.92	Rating **	M	Issue No.	10 (cont)	
LM End	0.93	Issue Type +	Ma	Location *		
Category	Supplemental			GPS Latitude/Longitude		
				Start	End	
Item	2017 Storm Damage			38.250875 °	38.250953 °	
				-121.711942 °	-121.712078 °	
DWR ID	DWR_RD2060_01_f_2017_10					
Comment Code						
Inspector Comment						
Levee Evaluation Comments						
Description:Sloughing commences approximately halfway down the water side slope.						
Site ID No:361						
Site Designation:LMA-188						
Repair Type: Erosion						
Rating:Area of Concern						
Field Date:7/12/2017						
Notes: Minor sloughing, mostly riprap has moved down the slope and into channel.

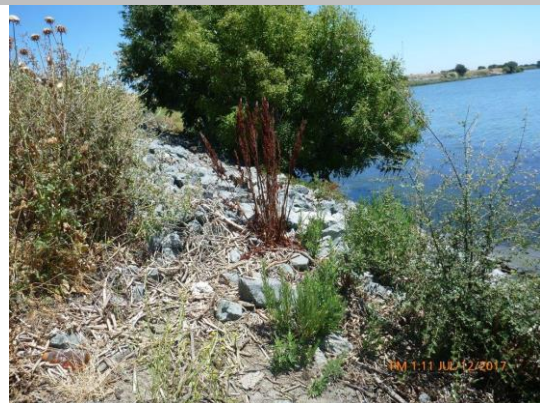
Photo 1 of 3 : SP_2018_RD2060_241_15_20180305_00017.jpg

LM Start	1.04	Rating **	M	Issue No.	15
LM End	1.08	Issue Type +	Ma	Location *	
Category	Supplemental			GPS Latitude/Longitude	
				Start	End
Item	2017 Storm Damage			38.251058 °	38.250872 °
				-121.714050 °	-121.714792 °
DWR ID	DWR_RD2060_01_f_2017_15				
Comment Code					
Inspector Comment					
Levee Evaluation Comments					
Description:Erosion commences approximately 3/4 of the way down the water side slope concentrated at the waterline.					
Site ID No:362					
Site Designation:LMA-189					
Repair Type: Erosion					
Rating:Area of Concern					
Field Date:7/12/2017					
Notes: Erosion due to lack of revetment. Erosion ends at riprap downstream. Vertical cut at summer wse.

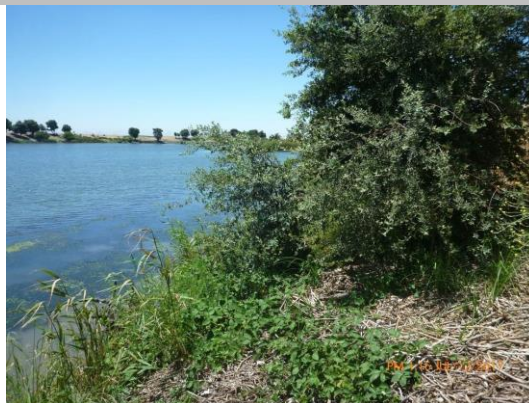
Photo 2 of 3 : SP_2018_RD2060_241_15_20180305_00018.jpg

LM Start	1.04	Rating **	M	Issue No.	15 (cont)
LM End	1.08	Issue Type +	Ma	Location *	
Category	Supplemental			GPS Latitude/Longitude	
				Start	End
Item	2017 Storm Damage			38.251058 °	38.250872 °
				-121.714050 °	-121.714792 °
DWR ID	DWR_RD2060_01_f_2017_15				
Comment Code					
Inspector Comment					
Levee Evaluation Comments					
Description:Erosion commences approximately 3/4 of the way down the water side slope concentrated at the waterline.					
Site ID No:362					
Site Designation:LMA-189					
Repair Type: Erosion					
Rating:Area of Concern					
Field Date:7/12/2017					
Notes: Erosion due to lack of revetment. Erosion ends at riprap downstream. Vertical cut at summer wse.

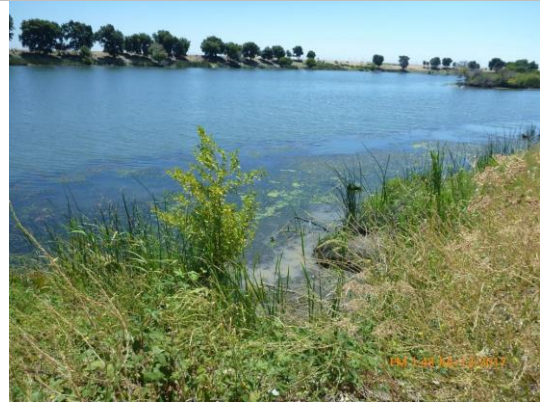
Photo 3 of 3 : SP_2018_RD2060_241_16_20180305_00022.jpg

LM Start	1.09	Rating **	M	Issue No.	16 (cont)	
LM End	1.10	Issue Type +	Ma	Location *		
Category	Supplemental			GPS Latitude/Longitude		
				Start	End	
Item	2017 Storm Damage			38.250844 °	38.250833 °	
				-121.714944 °	-121.714994 °	
DWR ID	DWR_RD2060_01_f_2017_16					
Comment Code						
Inspector Comment						
Levee Evaluation Comments						
Description:Erosion commences approximately halfway down the water side slope extending to the toe.						
Site ID No:363						
Site Designation:LMA-190						
Repair Type: Erosion						
Rating:Area of Concern						
Field Date:7/12/2017						
Notes: Small erosion up to high water line. Cuts into slope with 6' vertical cut.

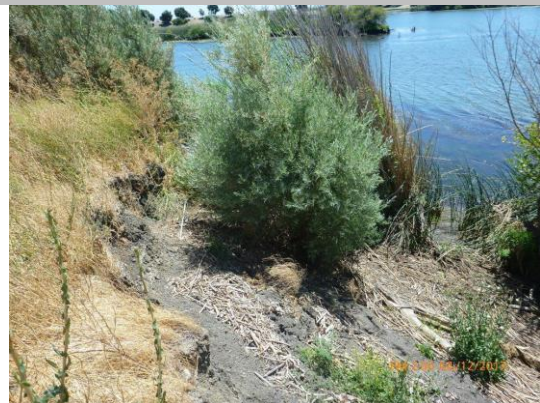
Photo 1 of 3 : SP_2018_RD2060_241_17_20180305_00023.jpg

LM Start	1.22	Rating **	A/W	Issue No.	17	
LM End	1.23	Issue Type +	Ma	Location *		
Category	Supplemental			GPS Latitude/Longitude		
				Start	End	
Item	2017 Storm Damage			38.251186 °	38.251289 °	
				-121.717114 °	-121.717264 °	
DWR ID	DWR_RD2060_01_f_2017_17					
Comment Code						
Inspector Comment						
Levee Evaluation Comments						
Description: Erosion commences approximately 1/4 of the way down the water side slope extending to the toe.						
Site ID No:364						
Site Designation:LMA-191						
Repair Type: Erosion						
Rating:Critical						
Field Date:7/12/2017						
Notes: Very deep erosion that extends halfway into slope. Intact riprap on both sdes of erosion. Rated serious but could be critical if erosion cuts deep into prism.

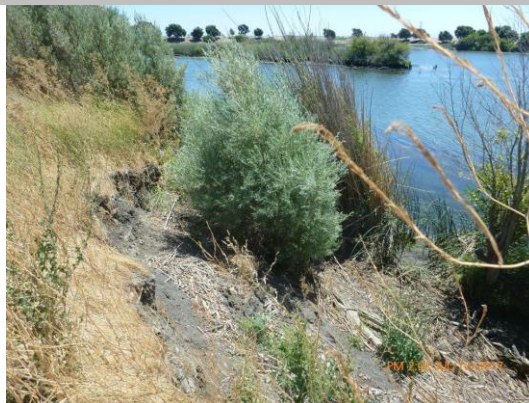
Photo 2 of 3 : SP_2018_RD2060_241_17_20180305_00024.jpg

LM Start	1.22	Rating **	A/W	Issue No.	17 (cont)	
LM End	1.23	Issue Type +	Ma	Location *		
Category	Supplemental			GPS Latitude/Longitude		
				Start	End	
Item	2017 Storm Damage			38.251186°	38.251289°	
				-121.717114°	-121.717264°	
DWR ID	DWR_RD2060_01_f_2017_17					
Comment Code						
Inspector Comment						
Levee Evaluation Comments						
Description:Erosion commences approximately 1/4 of the way down the water side slope extending to the toe.						
Site ID No:364						
Site Designation:LMA-191						
Repair Type: Erosion						
Rating:Critical						
Field Date:7/12/2017						
Notes: Very deep erosion that extends halfway into slope. Intact riprap on both sdes of erosion. Rated serious but could be critical if erosion cuts deep into prism.

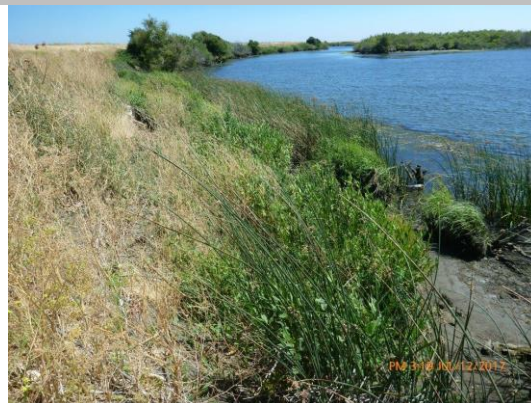
Photo 1 of 3 : SP_2018_RD2060_241_21_20180305_00029.jpg

LM Start	1.81	Rating **	A/W	Issue No.	21
LM End	1.84	Issue Type +	Ma	Location *	
Category	Supplemental			GPS Latitude/Longitude	
				Start	End
Item	2017 Storm Damage			38.255972 °	38.256247 °
				-121.724197 °	-121.724464 °
DWR ID	DWR_RD2060_01_f_2017_21				
Comment Code					
Inspector Comment					
Levee Evaluation Comments					
Description:Erosion commences approximately halfway down the water side slope extending to the toe. Some slipping into the toe has occurred due to deep erosion.					
Site ID No:366					
Site Designation:LMA-193					
Repair Type: Erosion					
Rating:Serious					
Field Date:7/12/2017					
Notes: Erosion extends halfway into the slope.

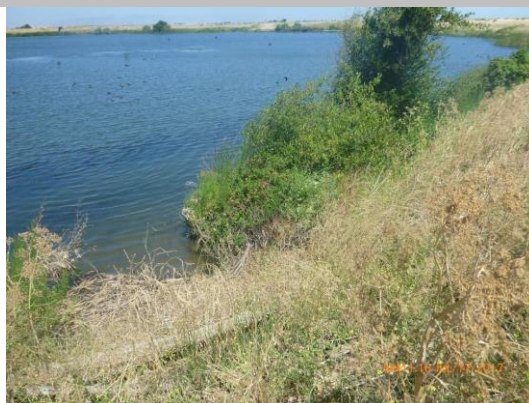
Photo 1 of 3 : SP_2018_RD2060_241_22_20180305_00032.jpg

LM Start	1.90	Rating **	M	Issue No.	22
LM End	1.95	Issue Type +	Ma	Location *	
Category	Supplemental			GPS Latitude/Longitude	
				Start	End
Item	2017 Storm Damage			38.257208 °	38.257842 °
				-121.724619 °	-121.724694 °
DWR ID	DWR_RD2060_01_f_2017_22				
Comment Code					
Inspector Comment					
Levee Evaluation Comments Description:Erosion commences approximately halfway down the water side slope extending to the toe. Some slipping into the toe has occurred. Site ID No:367 Site Designation:LMA-194 Repair Type: Erosion Rating:Area of Concern Field Date:7/12/2017 Notes: Minor crackingobserved below the hinge point and minor erosion at levee toe.

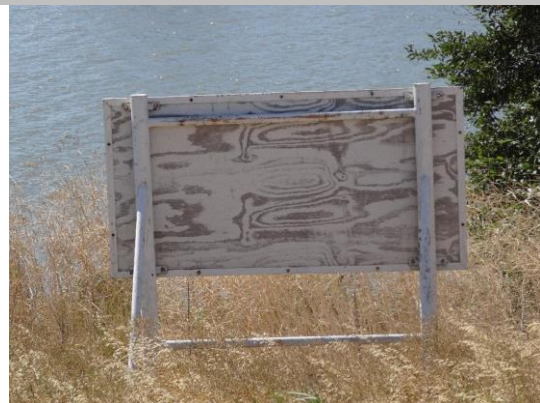
WS view: gasoline sign board on levee slope.

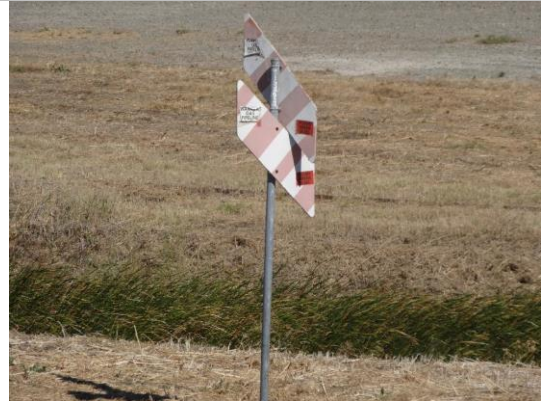
LS view: gasoline indicator across the road from levee toe.

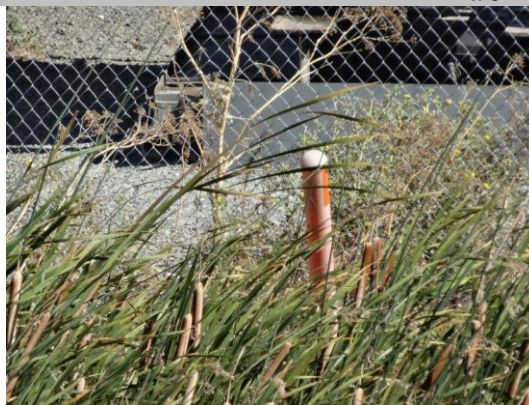
LS view: closer view of gasline indicator found on LS.

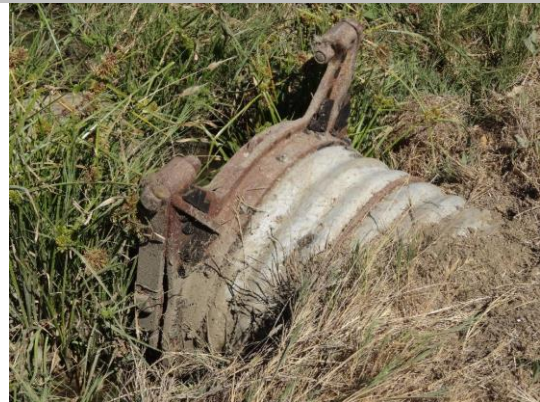
WS view: CM pipe with flap gate. Not accessible. Vegetation is partially blocking outlet pipe.

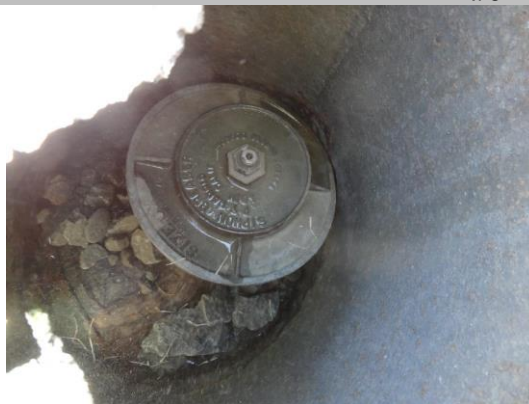
Waterside view: only leaky siphon breaker found.

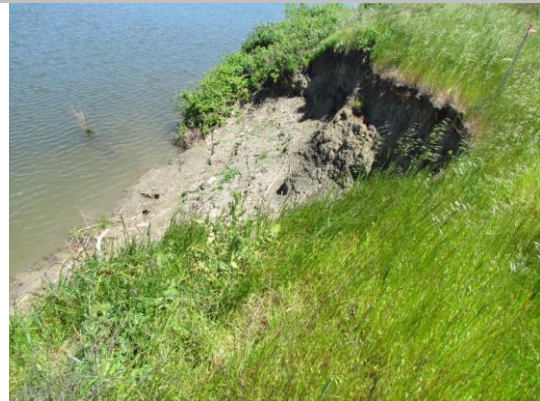
Looking downstream at the erosion in the waterside slope and toe.

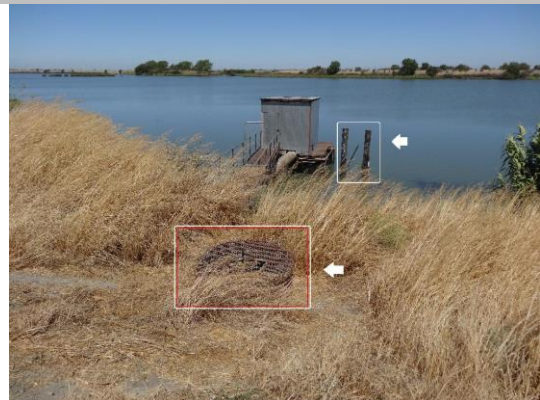
WS view: slide gate in CMP riser (bottom- marked) and may be abandoned pile for pump support (marked- right).

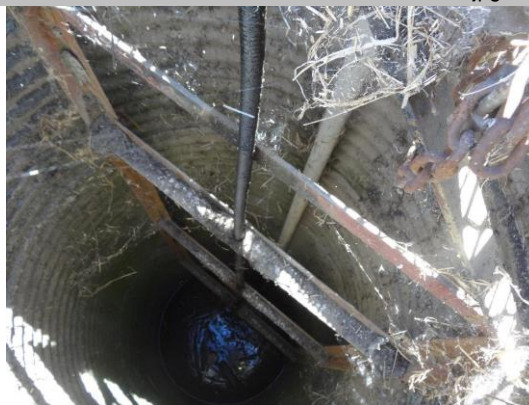
WS view: slide gate and air vent inside CMP riser.
